case study large objects and weapons

German WW2 Fi-103 (V1) Flying bomb

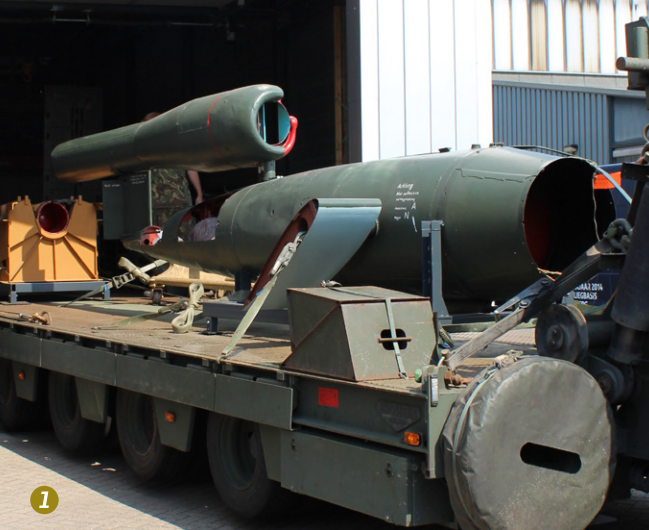
This particular example of a Fi-103 flying bomb had been used by the Dutch Army for instructional purposes. It had large sections of the hull cutaway, the engine was split in half, and the nose section was missing. The goal was to re-create an accurate impression of the original V1, retaining as much of the original material as possible.

1. the Fi-103 arriving at our workshop
2. CNC machined ribs forming the wing structure
3. restored hull and completed jet engine
4. the restored V1 on site, ready to be lifted in position
